A REPORT ON THE RISK MANAGEMENT OF THE TOSHIBA BMC6B

This report will be focusing on the Toshiba BMC6B (Shibaura) found in the machines shop division. The main issue is guarding, however, other safety hazards identified with respect to the Toshiba will also be included in the discussion.

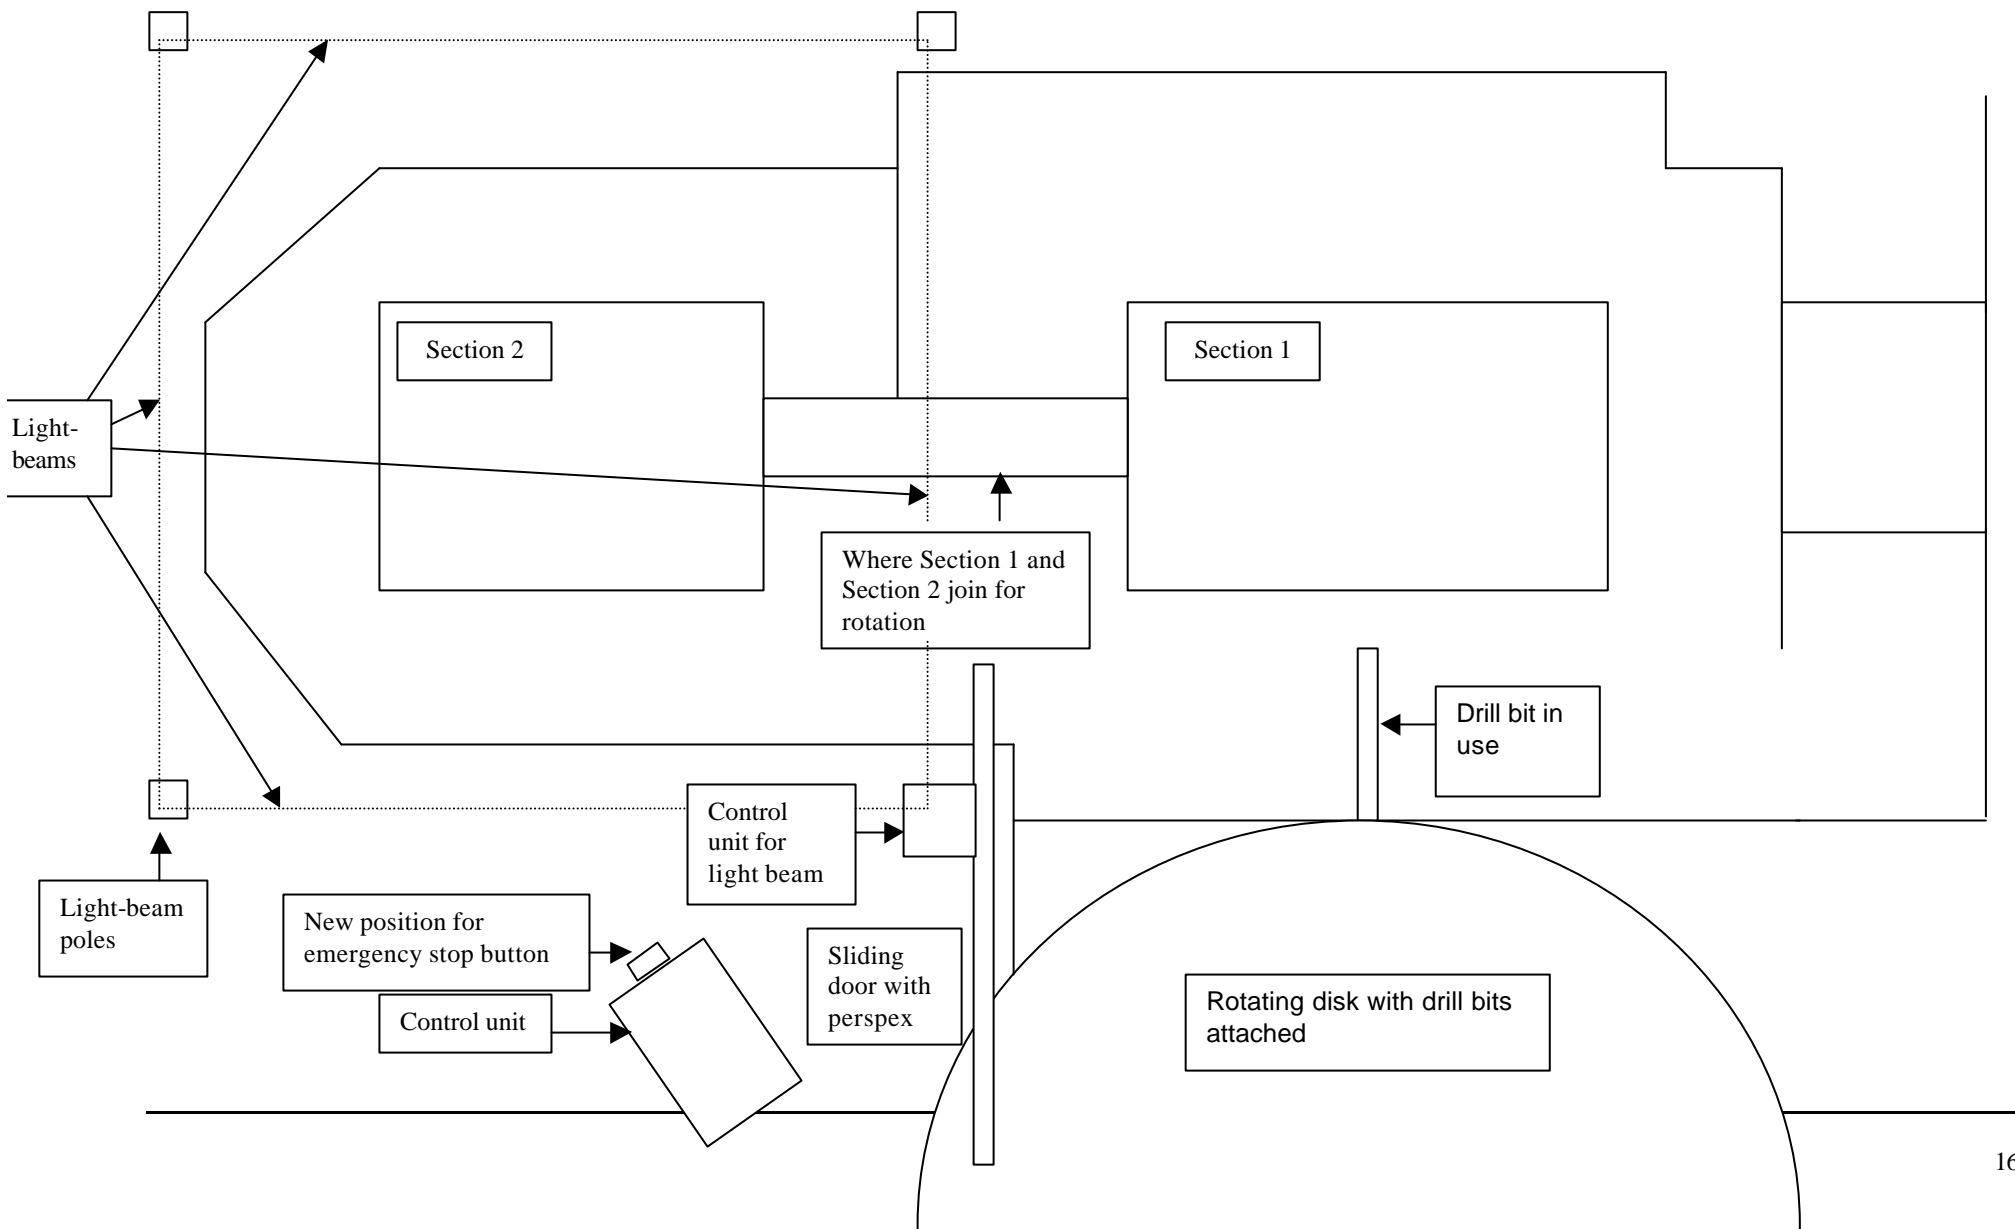
Appendix 4 – Diagram: Toshiba BMC6B with advised changes

Two forms of risk control integrating guarding and cut-outs have been identified. First is the use of concertina metal doors to encase the fore section of the machine (see Appendix 4). These doors should have interlocking at all joints. An advisable height is approximately 1.8m, as this prevents operator access to crush points from above (Miles pers. comm., 13/04/2000).

The second guard advised is to be situated in front of the drilling equipment (see Appendix 4). Here, a sliding door, with clear perspex inserted, could be

fitted. This allows the operator to monitor the process while being protected from the metal swarf. The door could be approximately 1.8m high to effectively block flying swarf, and fitted with a cut-out device.

Light-beams would be effective where used as a form of guarding the operator from the crush points using a cut-out system. Poles, containing the light

beams, would be situated at each corner (as demonstrated in Appendix 4) with light beams running from pole to pole. Any disruption of these beams could cause the machine to cease operation, and to restart operation the control unit would have to be manually adjusted.
